Re: Visual Site Inspection  
Caterpillar, Inc., Aurora Plant  
Montgomery, Illinois  
ILD 005 070 651

**Technical Enforcement Support  
at Hazardous Waste Sites  
Zone III  
Regions 5,6, and 7**

Resource Applications, Inc. (RAI), performed a preliminary assessment and visual site inspection (PA/VSI) to identify and assess the existence and likelihood of releases from solid waste management units (SWMU) and other areas of concern (AOC) at the Caterpillar Inc., Aurora Plant (Caterpillar) facility in Montgomery, Kendall County, Illinois. This summary highlights the results of the PA/VSI and the potential for releases of hazardous wastes or hazardous constituents from SWMUs and AOCs identified. In addition, a completed U.S. Environmental Protection Agency (EPA) Preliminary Assessment Form (EPA Form 2070-12) is included in Attachment A to assist in prioritizing RCRA facilities for corrective action.

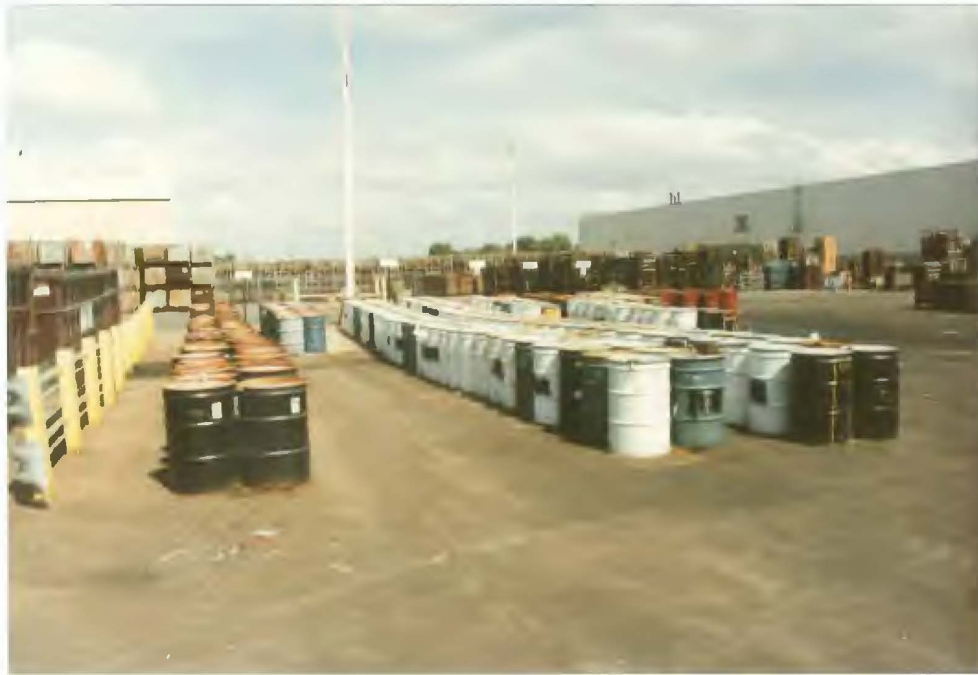
Photograph No. 1

Observations: Over 100 drums of various wastes were present at the drum storage area portion of this unit during the VSI. Several piles of sorted scrap metal were observed in the concrete bins. Some incinerator ash was blowing around. RAI noted no other evidence of release.

Description: This is the drummed waste storage (and hazardous waste storage) area of the Resource Recovery Area (SWMU 1). Hazardous wastes are stored for less than 90 days.

RAI recommends the incinerator ash be managed so that it does not become airborne.

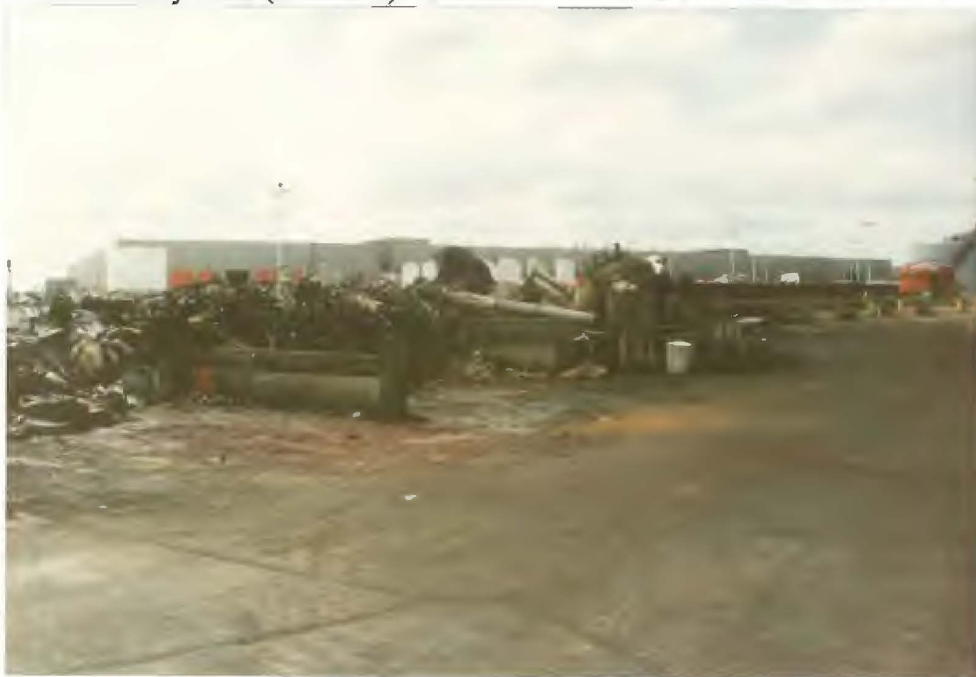
Photograph No. 2

Description: This is the bulk waste accumulation section of the Resource Recovery Area (SWMU 1)

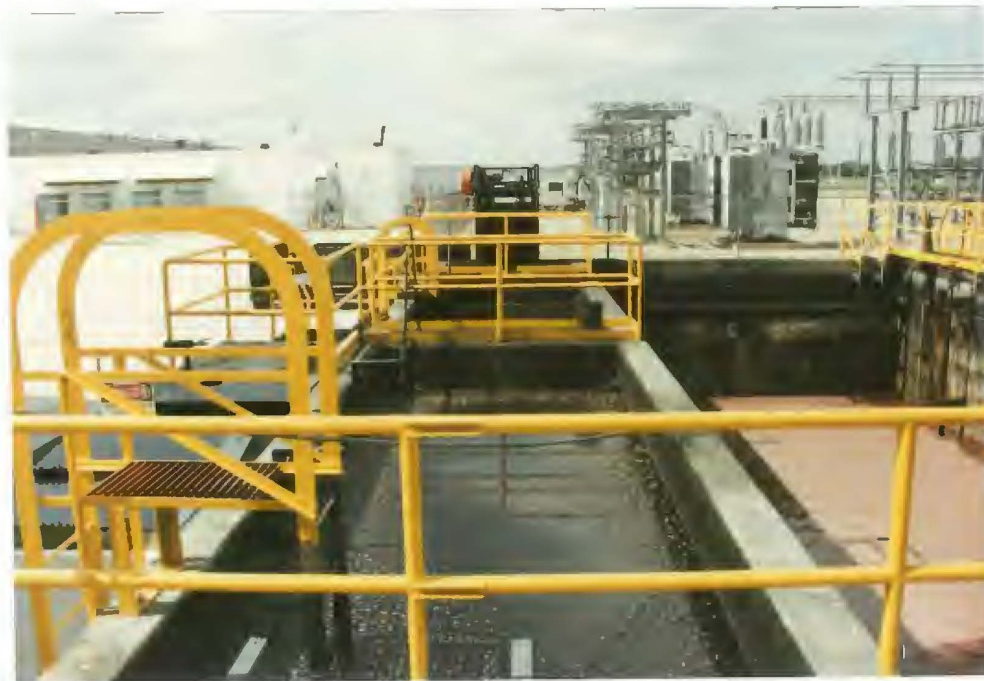
Photograph No. 3

Observations: The unit was in operation at the time of the VSI. The concrete that was visible was in good condition. RAI noted no evidence of release.

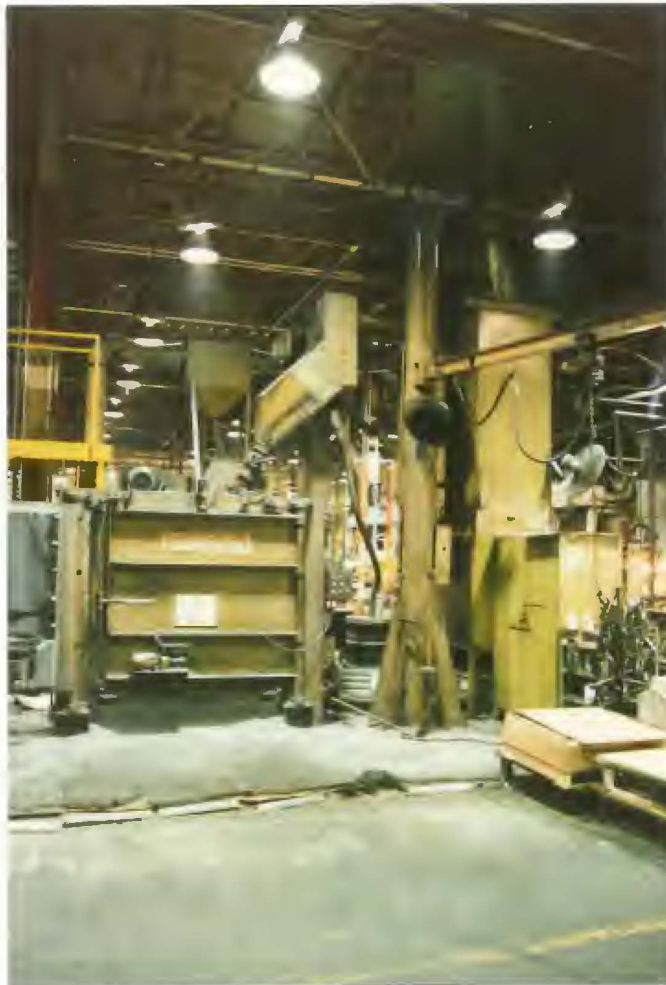
Photograph No. 5

Observations: The unit was not being used at the time of the VSI. RAI noted no evidence of release.

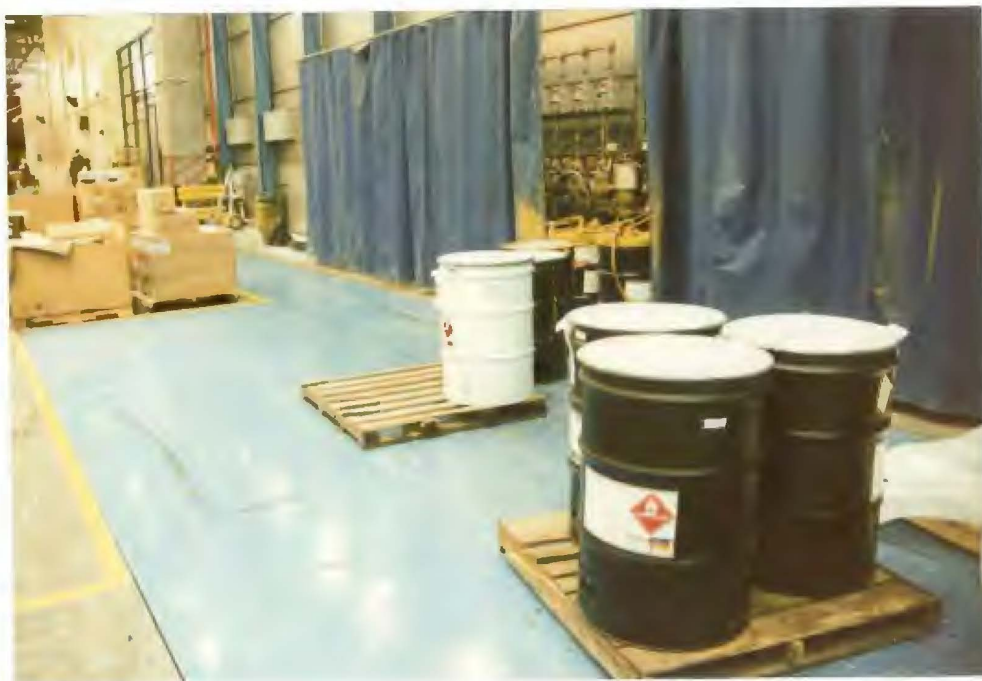
Photograph No. 6

Observations: The waste accumulation drum was not present at the time of the VSI. There were several product drums in this area. RAI noted no evidence of release.

Description: This is one of the Paint Sludge Satellite Accumulation Areas (in blue) where the paint waste is accumulated. All drums present are unused product (paint). No paint waste was present at the time the picture was taken.

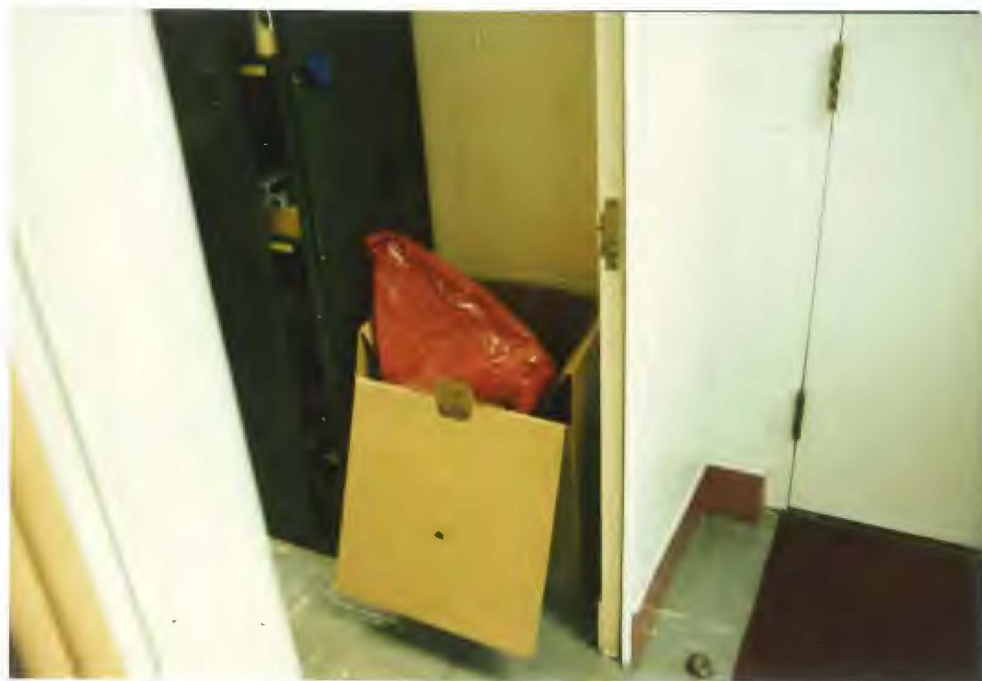
Photograph No. 7

Observations: At the time of the VSI, the bag was partially filled. RAI noted no evidence of release. The lid of the box was uncovered for the photograph.

Description: This is the Medical Waste Accumulation Area.

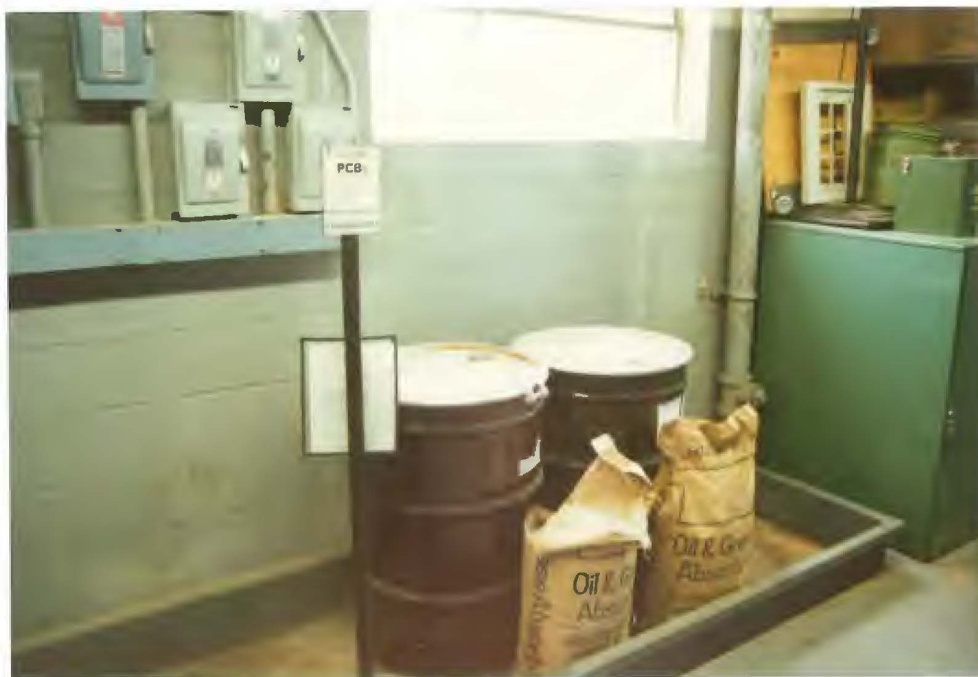
Photograph No. 8

Observations: The drums and steel bin were in good condition. Two boxes of unused oil and grease absorbent were also in the area. RAI noted no evidence of release.
